NORTH SYDNEY PEST MANAGEMENT Pty Ltd

Report No: 10267

STANDARDTIMBER PEST DETECTION REPORT

ADDRESS OF PROPERTY INSPECTED: **Common, 247 Burwood Road Concord NSW 2137**

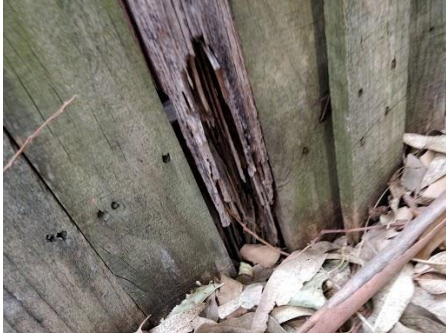
Termite workings were found to timber fence (Building 247N)

RECOMMENDATION Where evidence of damage to building timbers exists, competent advice (e.g. from a licensed and practicing building contractor) should be obtained to determine the extent of any structural damage and as to the need or otherwise for rectification or repair work. See also Item 3.1.5 'Frequency of Future Inspections' recommendation.

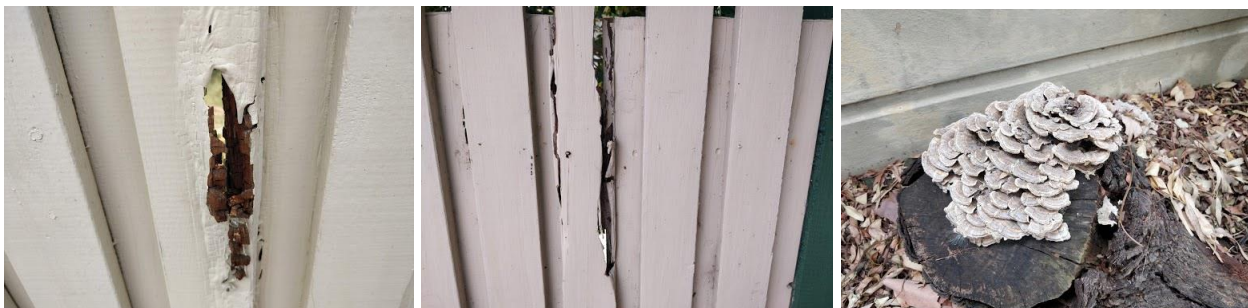
Fungal decay was found to fence timbers

Fungal decay was found to tree stumps around common area

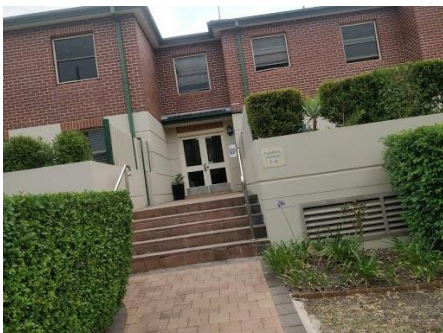
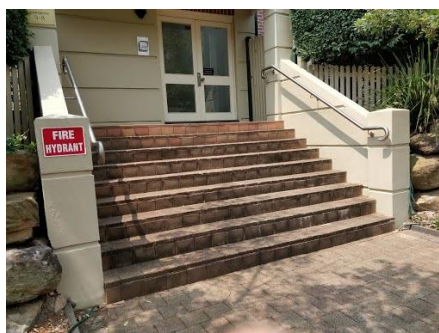
Dampcourse was found to be concealed by external steps, pavements and earth

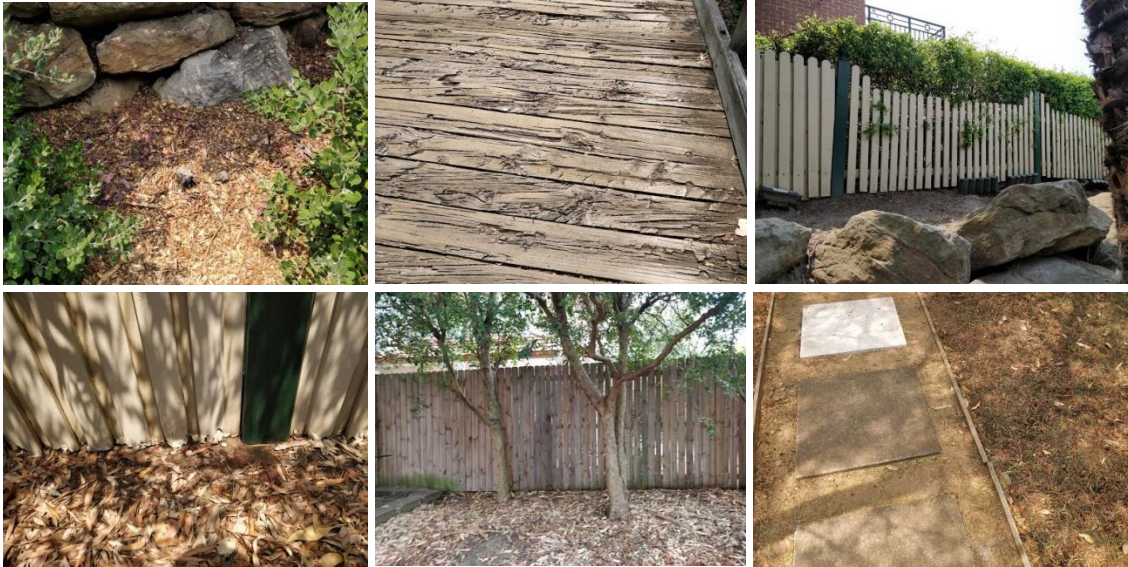
- Timber fence in direct contact with ground**
- Wood chip on ground and against exterior wall**
- Wood chip on the ground to garden areas**
- Timber retaining walls in direct contact with ground**
- Timber garden borders in ground**
- Timber decking has ground contact**
- Wooden bridge in contact with ground (Building 247R)**

- Recommend to remove stumps from around the grounds
- Recommend to remove non structural timber from around the grounds
- Recommend to replace timber fences with colourbond steel
- Recommend to replace timber retaining walls with a masonry product
- Recommend to replace timber garden borders with masonry product
- Recommend to remove vegetation away from exterior walls
- Recommend to remove woodchip away from exterior walls and garden areas

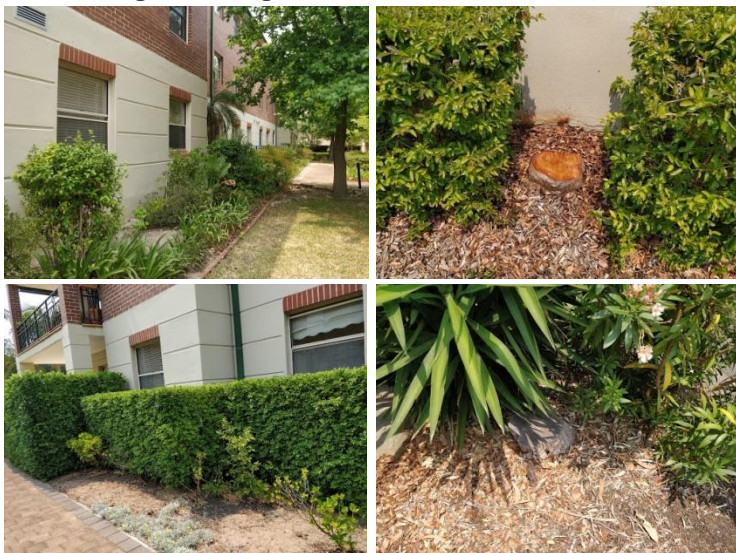
- Tree stumps in ground to common areas**
- Vegetation against exterior walls**
- Excess vegetation against fence lines**
