# Tree Risk Assessment

Phillips Landing  
247 Burwood Road, Concord  
NSW, 2137  
DP 270051  
Job No: 26108  
10/08/2026

**Temporal Tree Management Pty Ltd.**

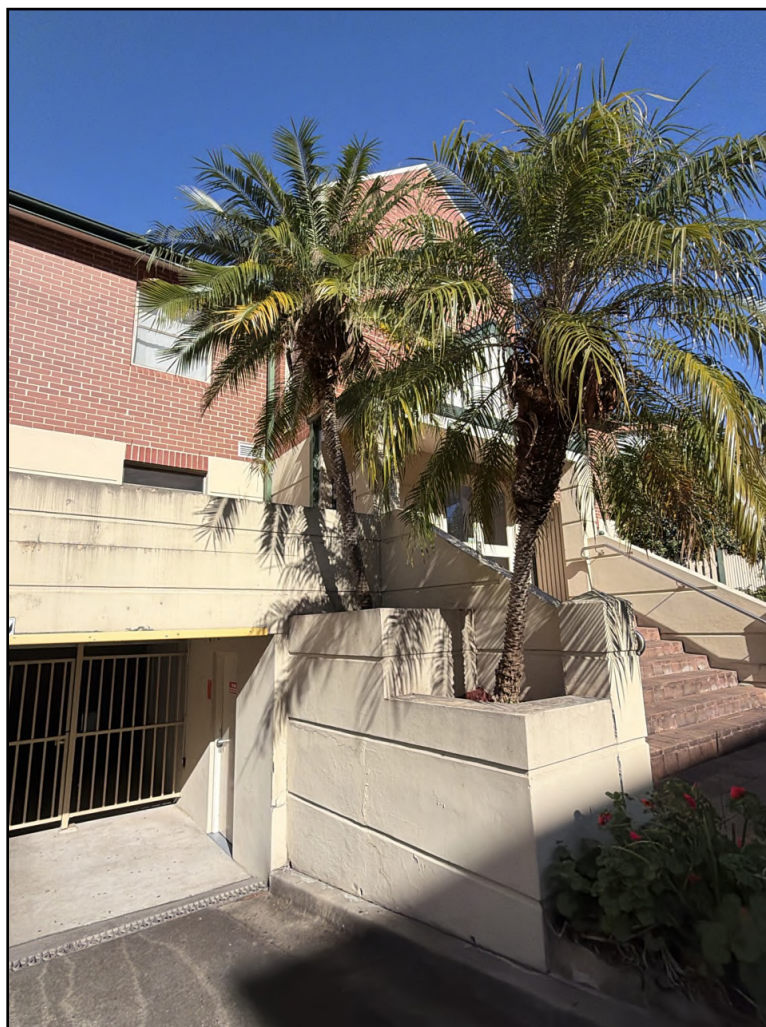
Tree No. : 90

| Tree | Scientific Name | Common Name | Maturity | Height [m] | Canopy Width (m) | DBH [cm] | Health | Structure | ULE | Landscape Value | Risk Rating | Work Recommendations | Priority | Tree Comments |
|---|---|---|---|---|---|---|---|---|---|---|---|---|---|---|
| 90 | <i>Phoenix roebelinii</i> | pygmy date palm | Mature | 2 | 2 | 10 | Good | Fair | Short | Moderate | Low | Engage Structural Engineer to assess severity of damage to retaining walls adjacent to palm. If damage requires remediation, palm may require removal. | High | Small palm growing in confined raised garden bed. Major cracking and displacement in retaining wall. Root growth from palm may have contributed to observed damage. |

Engage Structural Engineer to assess severity of damage to retaining walls adjacent to palm. If damage require remediation, palm may require removal.

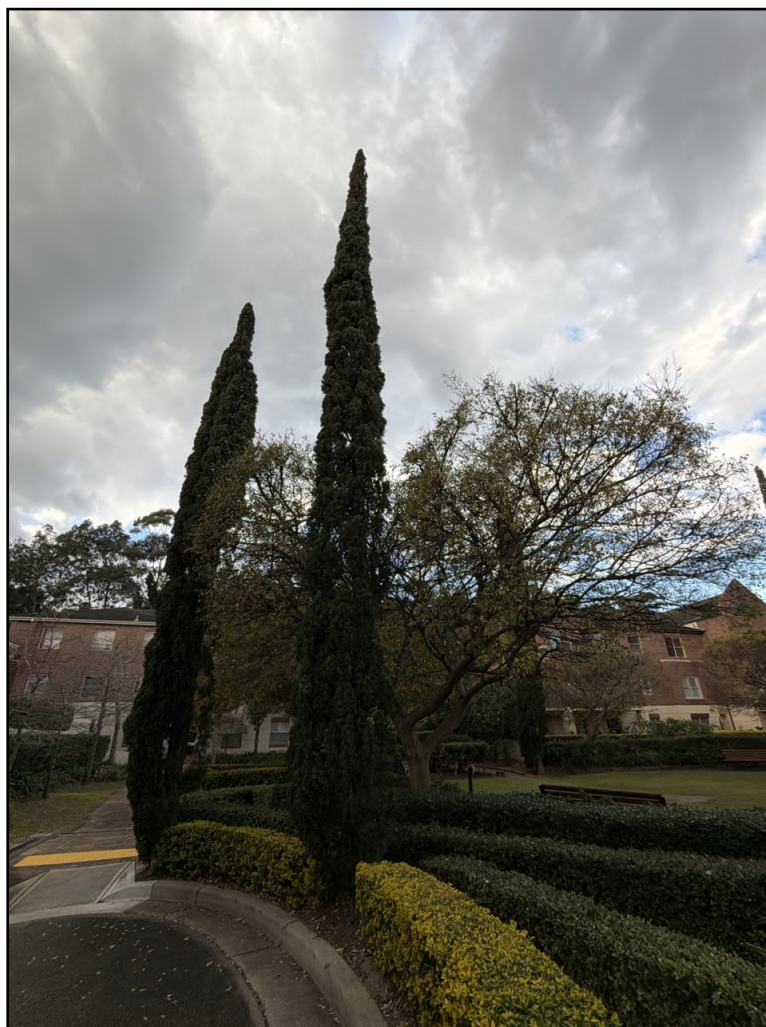
Tree No. : 179

| Tree | Scientific Name | Common Name | Maturity | Height [m] | Canopy Width (m) | DBH [cm] | Health | Structure | ULE | Landscape Value | Risk Rating | Work Recommendations | Priority | Tree Comments |
|---|---|---|---|---|---|---|---|---|---|---|---|---|---|---|
| 179 | <i>Cupressus sempervirens</i> | Italian Cypress | Mature | 12 | 1 | 15 | Fair | Good | Medium | High | Low | Reinspect tree within 6 months to monitor dieback and determine if tree is infected with Cypress canker. | High | Large tree of ornamental species observed to be in mostly good condition. Canopy with isolated patches of foliar dieback. Possibly symptom of Cypress Canker. |

Reinspect tree within 6 months to monitor dieback and determine if tree is infected with Cypress canker.

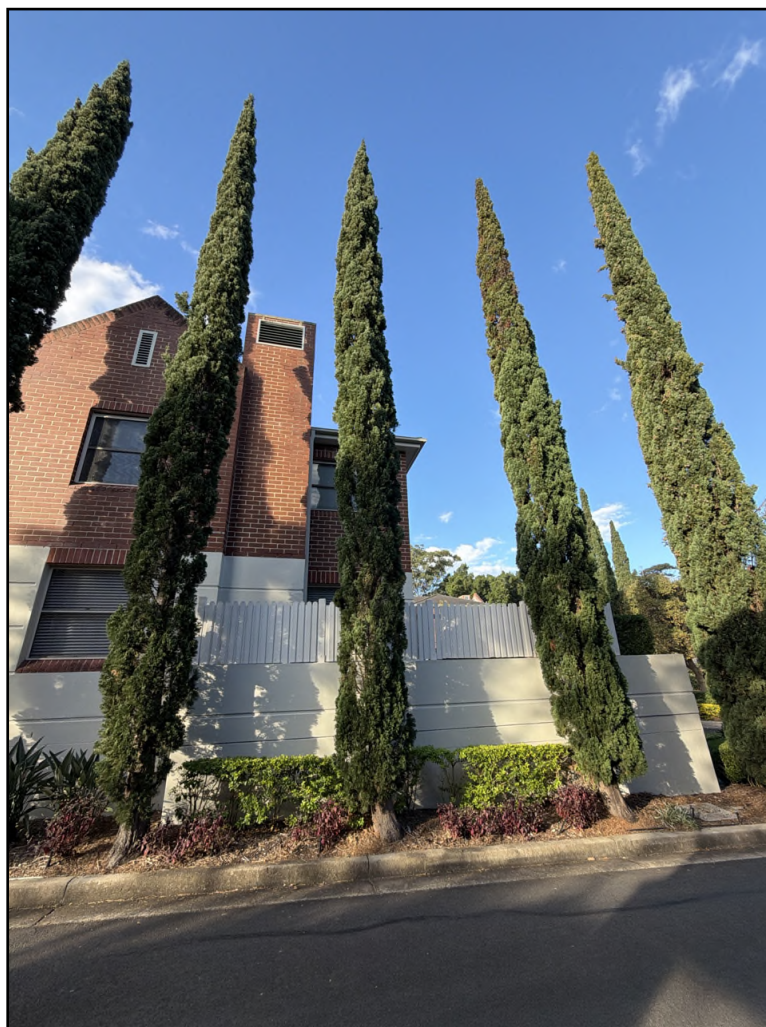
Tree No. : 184

| Tree | Scientific Name | Common Name | Maturity | Height [m] | Canopy Width (m) | DBH [cm] | Health | Structure | ULE | Landscape Value | Risk Rating | Work Recommendations | Priority | Tree Comments |
|---|---|---|---|---|---|---|---|---|---|---|---|---|---|---|
| 184 | <i>Cupressus sempervirens</i> | Italian Cypress | Semi mature | 12 | 1 | 15 | Good | Good | Long | Moderate | Low | Reinspect tree after 6 months to monitor canopy for continued signs of dieback that may indicate Cypress Canker infection. | High | Large tree of ornamental species observed to be in mostly good condition. Canopy with isolated patches of foliar dieback. Possibly symptom of Cypress Canker. |

Reinspect tree after 6 months to monitor canopy for continued signs of dieback that may indicate Cypress Canker infection.

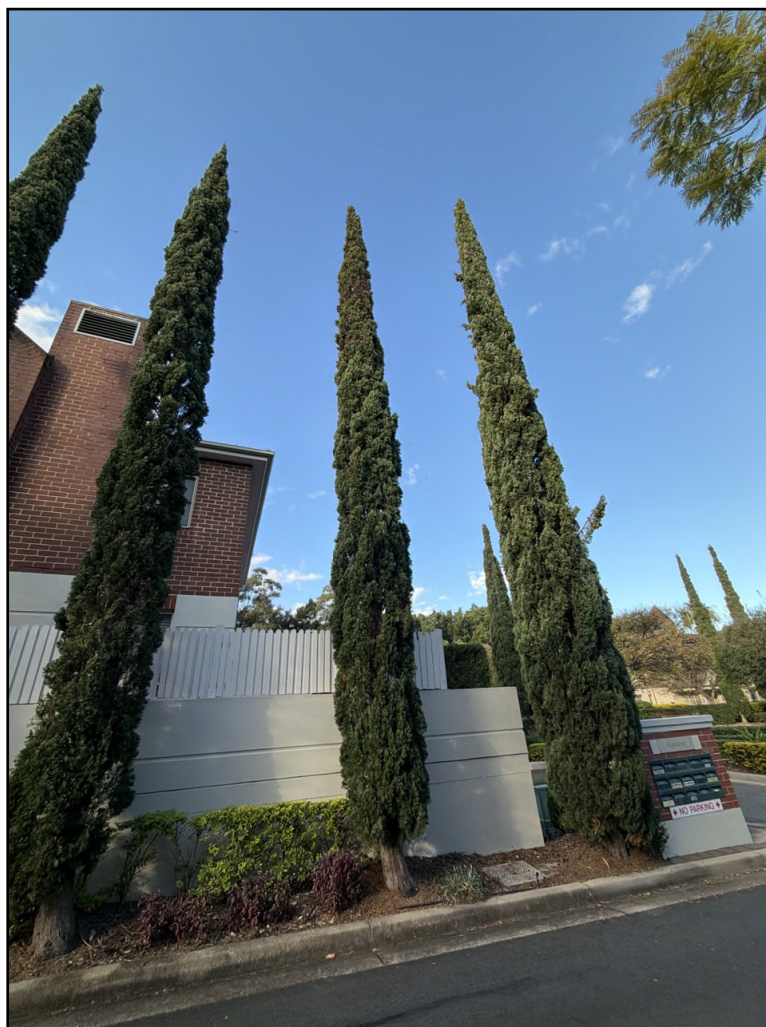
Tree No. : 185

| Tree | Scientific Name | Common Name | Maturity | Height [m] | Canopy Width (m) | DBH [cm] | Health | Structure | ULE | Landscape Value | Risk Rating | Work Recommendations | Priority | Tree Comments |
|---|---|---|---|---|---|---|---|---|---|---|---|---|---|---|
| 185 | <i>Cupressus sempervirens</i> | Italian Cypress | Mature | 12 | 1 | 15 | Fair | Good | Medium | High | Low | Reinspect tree after 6 months to monitor canopy for continued signs of dieback that may indicate Cypress Canker infection. | High | Large tree of ornamental species observed to be in mostly good condition. Canopy with large patches of foliar dieback. Indicates tree is infected with Cypress Canker. |

Reinspect tree after 6 months to monitor canopy for continued signs of dieback that may indicate Cypress Canker infection.

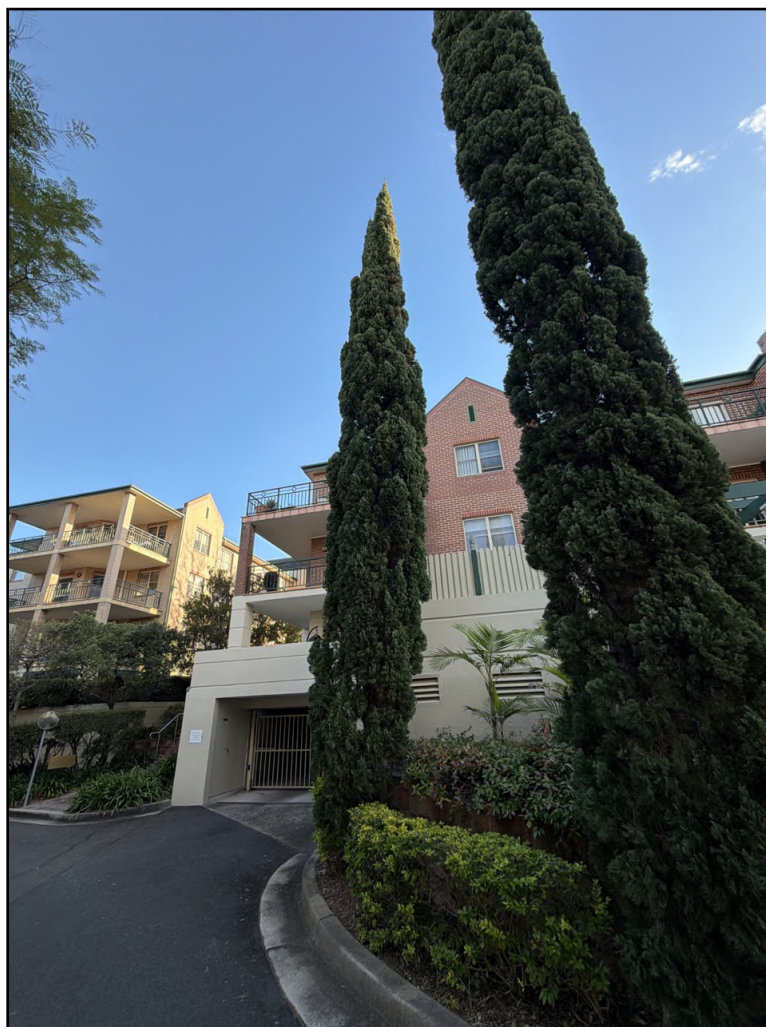
Tree No. : 197

| Tree | Scientific Name | Common Name | Maturity | Height [m] | Canopy Width (m) | DBH [cm] | Health | Structure | ULE | Landscape Value | Risk Rating | Work Recommendations | Priority | Tree Comments |
|---|---|---|---|---|---|---|---|---|---|---|---|---|---|---|
| 197 | <i>Cupressus sempervirens</i> | Italian Cypress | Mature | 10 | 1 | 20 | Fair | Good | Medium | High | Low | Reinspect tree after 6 months to monitor canopy for continued signs of dieback that may indicate Cypress Canker infection. | High | Large tree of ornamental species observed to be in mostly good condition. Canopy with small patches of foliar dieback. Indicates tree may be infected with Cypress Canker. |

Reinspect tree after 6 months to monitor canopy for continued signs of dieback that may indicate Cypress Canker infection.

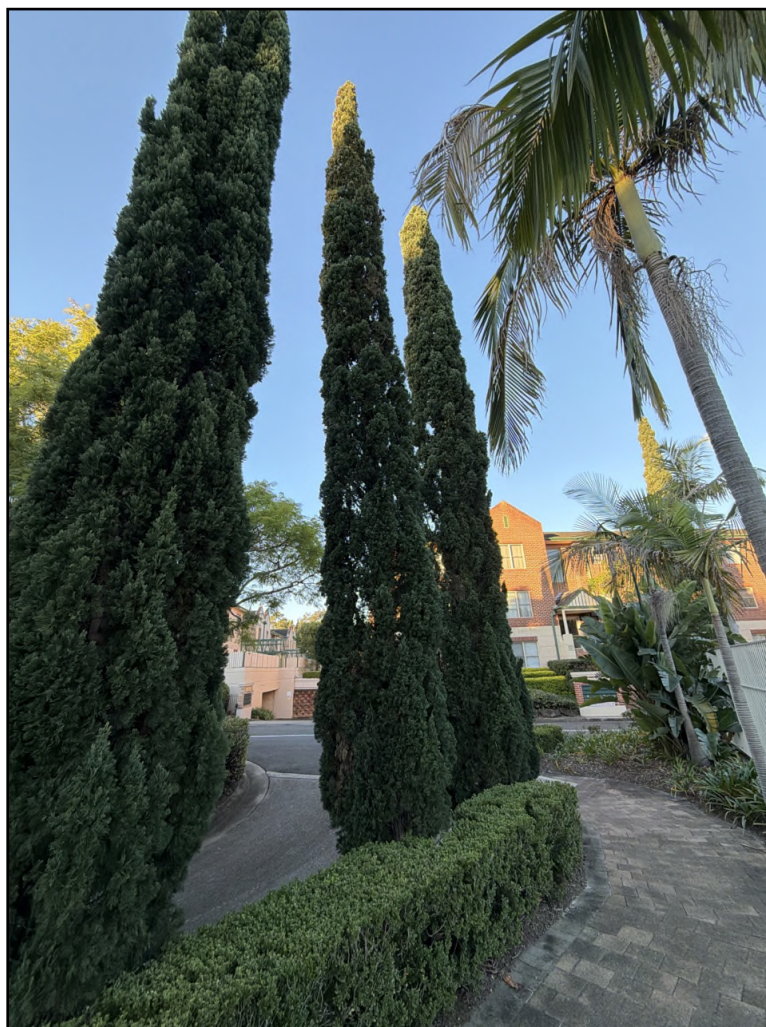
Tree No. : 216

| Tree | Scientific Name | Common Name | Maturity | Height [m] | Canopy Width (m) | DBH [cm] | Health | Structure | ULE | Landscape Value | Risk Rating | Work Recommendations | Priority | Tree Comments |
|---|---|---|---|---|---|---|---|---|---|---|---|---|---|---|
| 216 | <i>Cupressus sempervirens</i> | Italian Cypress | Mature | 10 | 1 | 15 | Fair | Good | Medium | High | Low | Reinspect tree after 6 months to monitor canopy for continued signs of dieback that may indicate Cypress Canker infection. | High | Large tree of ornamental species observed to be in mostly good condition. Growing on confined location. Minor displacement of pavers adjacent to stem. No trip hazard observed. Small patches of tissue necrosis observed in canopy, which may indicate Cypress Canker infection. |

Reinspect tree after 6 months to monitor canopy for continued signs of dieback that may indicate Cypress Canker infection.

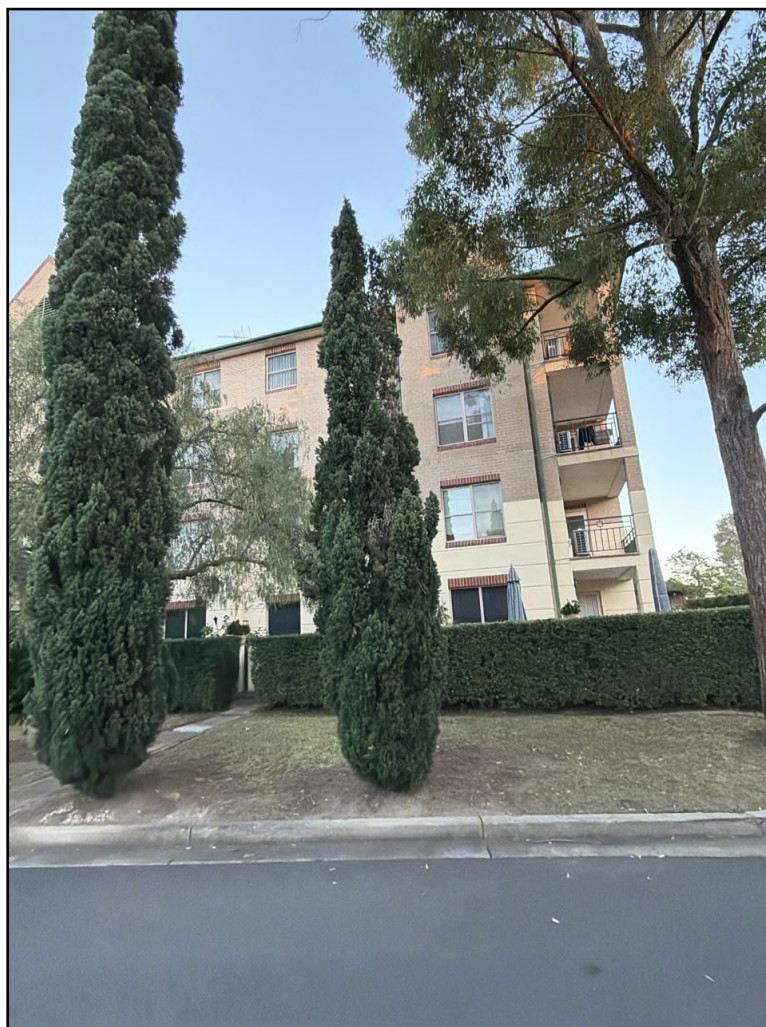
Tree No. : 237

| Tree | Scientific Name | Common Name | Maturity | Height [m] | Canopy Width (m) | DBH [cm] | Health | Structure | ULE | Landscape Value | Risk Rating | Work Recommendations | Priority | Tree Comments |
|---|---|---|---|---|---|---|---|---|---|---|---|---|---|---|
| 237 | <i>Cupressus sempervirens</i> | Italian Cypress | Semi mature | 5 | 1 | 20 | Good | Good | Long | High | Low | Reinspect tree after 6 months to monitor canopy for signs of continued dieback associated with Cypress Canker. | High | Maturing tree of ornamental species observed to be in good condition. Canopy with small patches of dieback within canopy indicating it may be infected with Cypress Canker. |

Reinspect tree after 6 months to monitor canopy for signs of continued dieback associated with Cypress Canker.

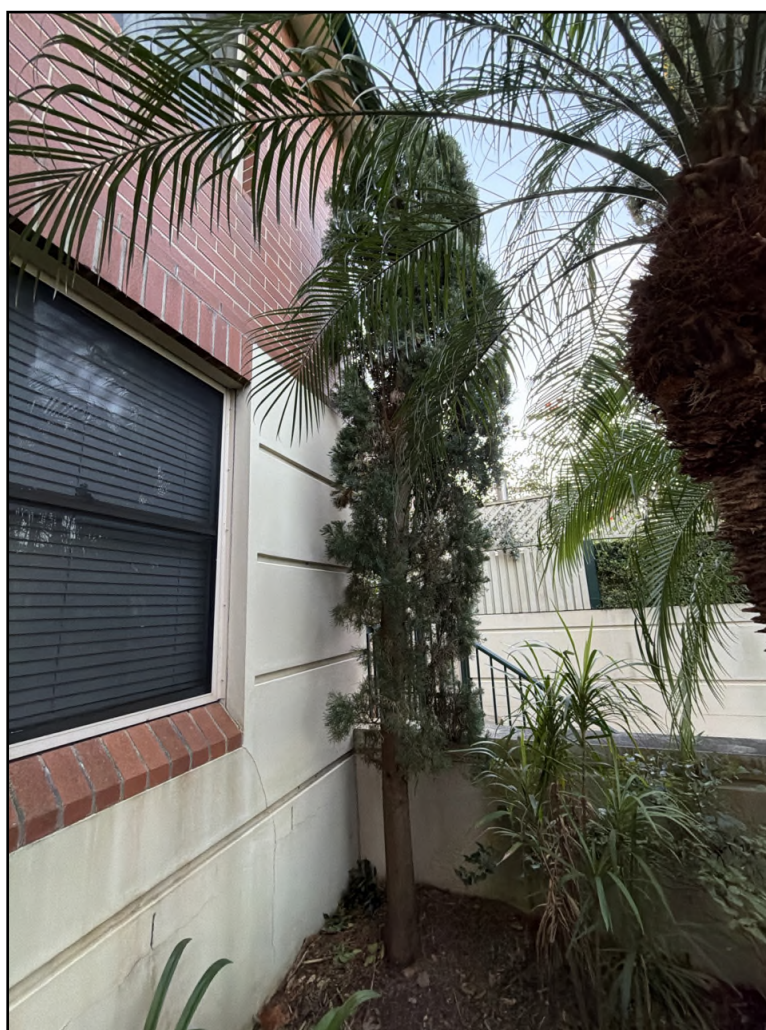
Tree No. : 259

| Tree | Scientific Name | Common Name | Maturity | Height [m] | Canopy Width (m) | DBH [cm] | Health | Structure | ULE | Landscape Value | Risk Rating | Work Recommendations | Priority | Tree Comments |
|---|---|---|---|---|---|---|---|---|---|---|---|---|---|---|
| 259 | <i>Cupressus sempervirens</i> | Italian Cypress | Mature | 6 | 1 | 10 | Good | Good | Long | High | Low | Further investigation required to determine severity of observed damage to external wall and whether remedial construction works are required. If damage requires remediation, tree may require removal. | High | Maturing tree of ornamental species observed to be in mostly good condition. Stem positioned 0.5 metres from external wall of adjacent building. Cracking observed in wall. Root growth from tree may have contributed to the observed damage to the wall. |

Further investigation required to determine severity of observed damage to external wall and whether remedial construction works are required. If damage requires remediation, tree may require removal.

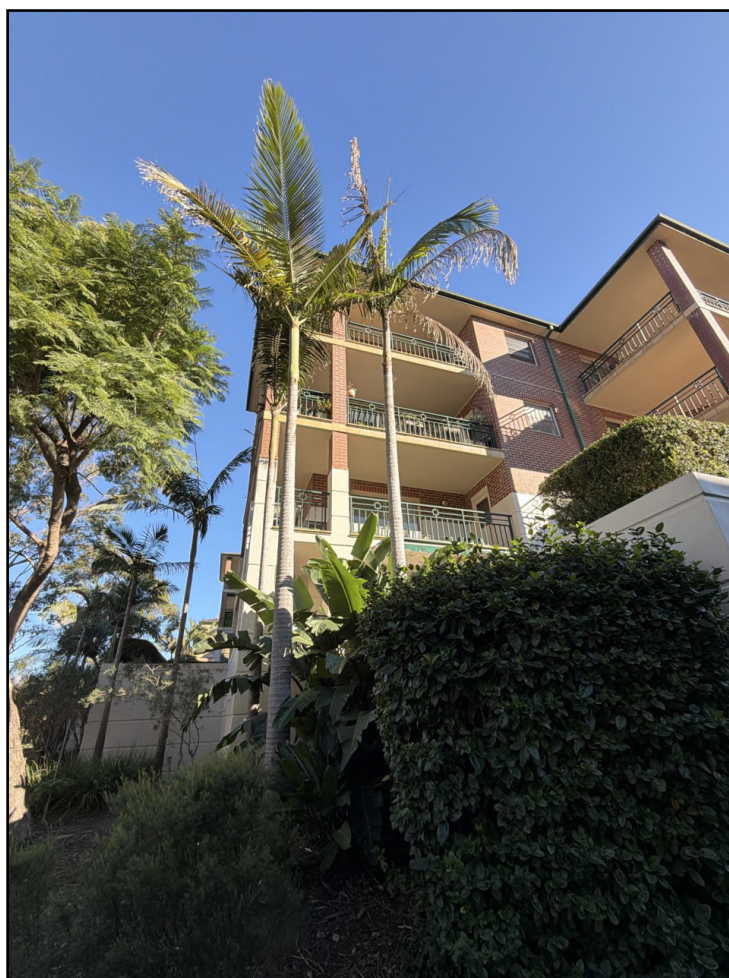
Tree No. : 51

Displacement of the concrete structures was observed adjacent to Tree 51. While this tree is small, its species (*Jacaranda mimosifolia*) is capable of causing structural damage and its root growth is likely to have contributed to the displacement of these structures. If required, it is recommended that the trip hazards are remediated with further concrete grinding. Replacement of the structures should be undertaken if damage worsens. Due to its small size and suitable distance from the kerb, it is recommended that Tree 51 is not removed to facilitate these works. Instead, root pruning should be undertaken by a suitably qualified Arborist (minimum AQF Level 5) during excavation required for remediation works. Root pruning must be undertaken in accordance with *the Australian Standard for Pruning Amenity Trees (AS4373 2007)*.

Continue to remediate trip hazard with grinding and asphalt edging where required. Replacement for kerb, gutter and driveway may be required if displacement worsens considerably. In this case, a suitably qualified arborist (minimum AQF Level 5) should be present to monitor excavation and undertake root pruning of roots up to 60mm in diameter where required. Reduce epicormic growth within canopy by one-third to restore more suitable canopy form. Target most upright epicormic branches. Max cut diameter
