Report On The Appearance of Each of the 15 Strata Blocks

PHILLIP'S LANDING COMMUNITY ASSOCIATION

247 Burwood Road
Concord NSW 2137

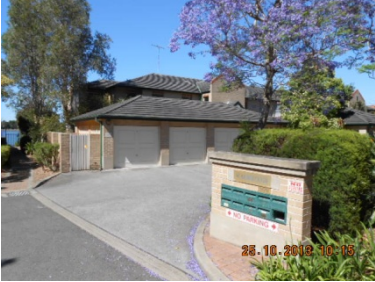
Item No.	Photo	Recommended Control Measure	Trade
EXTERNAL FACADE PAINT CONDITION			
1	<p>Block M</p>

<p>Block M - The rendered facade and bayside columns need painting as soon as possible. The downpipe rainwater heads are showing signs of rust on the southern side of the building. The gutter brackets are showing signs of rust.</p> <p>Recommendation to action: Quarter 1 – Action required within 3 months</p>	Painter / Roof plumber
2	<p>Block N</p>

TO DO LIST
QUARTER 1 – ACTION REQUIRED WITHIN 3 MONTHS
1. Block M - The rendered facade and bayside columns need painting as soon as possible . The downpipe rainwater heads are showing signs of rust on the southern side of the building. The gutter brackets are showing signs of rust.

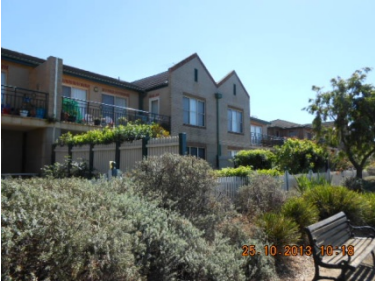
<p>Block N - The rendered facade and bayside columns need painting as soon as possible. The downpipe rainwater heads are showing signs of rust on the southern side of the building. The gutter brackets are showing signs of rust. There is evidence of stained rendered surface.</p> <p>Recommendation to action: Quarter 1 – Action required within 3 months</p>	Painter / Roof plumber
3	<p>Block P</p>

2. Block N - The rendered facade and bayside columns need painting as soon as possible . The downpipe rainwater heads are showing signs of rust on the southern side of the building. The gutter brackets are showing signs of rust. There is evidence of stained rendered surface.

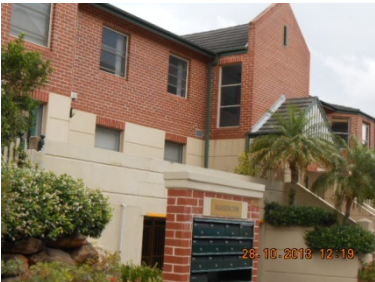
<p>Block P - The rendered facade and bayside columns need painting as soon as possible. The downpipe rainwater heads are showing signs of rust on the southern side of the building. The gutter brackets are showing signs of rust. The building needs attention.</p> <p>Recommendation to action: Quarter 1 – Action required within 3 months</p>	Painter

3. Block P - The rendered facade and bayside columns need painting as soon as possible . The downpipe rainwater heads are showing signs of rust on the southern side of the building. The gutter brackets are showing signs of rust. The building needs attention.

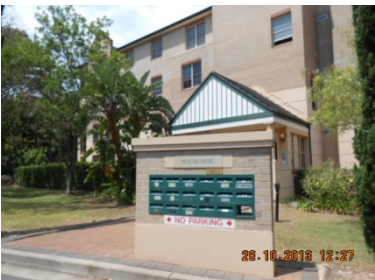
4	<p>Block J</p>

<p>Block J - We recommend the garden bed planter box walls are attended to, and paint is needed to the external facade ceiling eaves lining.</p> <p>Recommendation to action: Quarter 1 – Action required within 3 months</p>	Painter

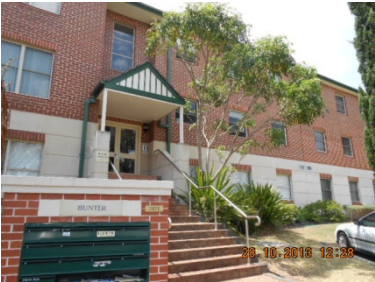
Item No.	Photo	Recommended Control Measure	Trade
5	<p>Block E</p>

<p>Block E - All rendered and painted surfaces are to be attended to, and paint is needed to the external facade ceiling eaves lining.</p> <p>Recommendation to action: Quarter 1 – Action required within 3 months</p>	Painter
6	<p>Block B</p>

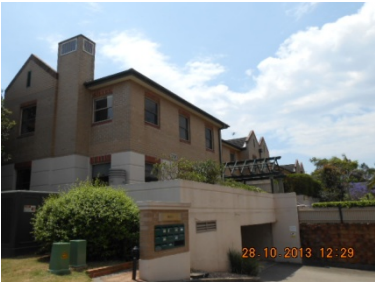
<p>Block B - All rendered and painted surfaces are to be attended to, and paint is needed to the external facade ceiling eaves lining. The rendered surfaces need repair.</p> <p>Recommendation to action: Quarter 1 – Action required within 3 months</p>	Painter
7	<p>Block H</p>

6. Block B - All rendered and painted surfaces are to be attended to, and paint is needed to the external facade ceiling eaves lining. The rendered surfaces need repair.

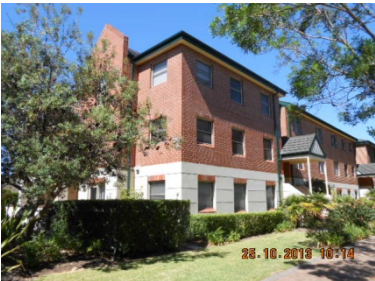
<p>Block H - We recommend the external painting and general upkeep to be re-done in 5-8 years.</p> <p>Recommendation to action: Quarter 4 – Action required within 12 months</p>	Painter
8	<p>Block D</p>

10. Block H - We recommend the external painting and general upkeep to be re-done in 5-8 years.

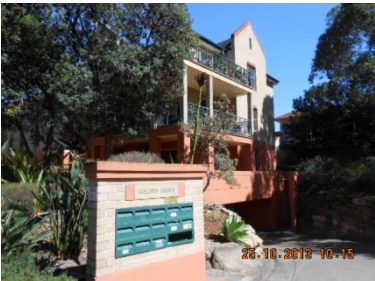
<p>Block D - The timber fascia needs painting.</p> <p>Recommendation to action: Quarter 4 – Action required within 12 months</p>	Painter

11. Block D - The timber fascia needs painting.

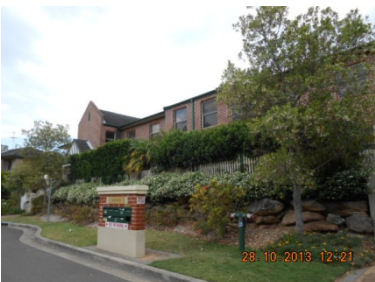
9	<p>Block R</p>

<p>Block R - We recommend the external painting and general upkeep to be re-done in 5-8 years.</p> <p>Recommendation to action: Quarter 4 – Action required within 12 months</p>	Painter
10	<p>Block L</p>

12. Block R - We recommend the external painting and general upkeep to be re-done in 5-8 years.

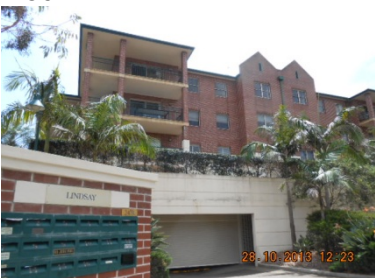
<p>Block L - We recommend the external painting and general upkeep to be re-done in 5-8 years.</p> <p>Recommendation to action: Quarter 4 – Action required within 12 months</p>	Painter

13. Block L - We recommend the external painting and general upkeep to be re-done in 5-8 years.

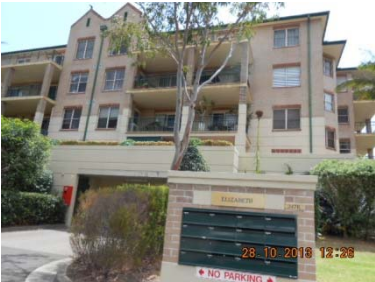
Item No.	Photo	Recommended Control Measure	Trade
11	<p>Block K</p>

<p>Block K - We - recommend the external painting and general upkeep to be re-done in 5-8 years.</p> <p>Recommendation to action: Quarter 4 – Action required within 12 months</p>	Painter
12	<p>Block A</p>

14. Block K - We - recommend the external painting and general upkeep to be re-done in 5-8 years.

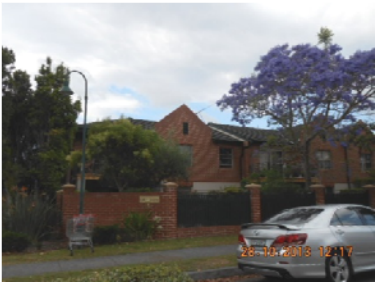
<p>Block A - Work was in progress during the site inspection, timber fascia, rendered facade and balcony ceilings are in good order.</p>	
EXTERNAL FASADE PAINT CONDITION			
13	<p>Block C</p>

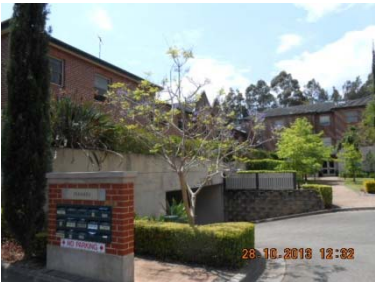
<p>Block C - All rendered and painted surfaces are to be attended to. Paint is needed to the external facade ceiling eaves lining, especially the rendered walls over the entry to the basement and towards the centre garden courtyard.</p> <p>Recommendation to action: Quarter 1 – Action required within 3 months</p>	Painter
14	<p>Block F</p>

7. Block C - All rendered and painted surfaces are to be attended to. Paint is needed to the external facade ceiling eaves lining, especially the rendered walls over the entry to the basement and towards the centre garden courtyard.

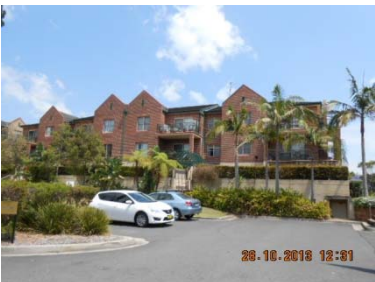
<p>Block F - All rendered and painted surfaces are to be attended to, and paint is needed to the external facade ceiling eaves lining.</p> <p>Recommendation to action: Quarter 1 – Action required within 3 months</p>	Painter

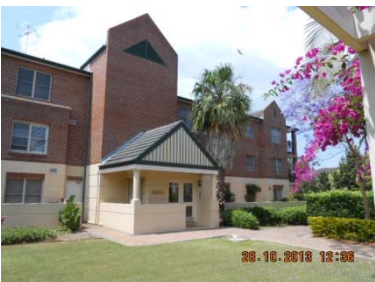
15	<p>Block G</p>

<p>Block G - We recommend the external painting and general upkeep to be re-done in 5-8 years.</p> <p>Recommendation to action: Quarter 4 – Action required within 12 months</p>	Painter

15. Block G - We recommend the external painting and general upkeep to be re-done in 5-8 years.

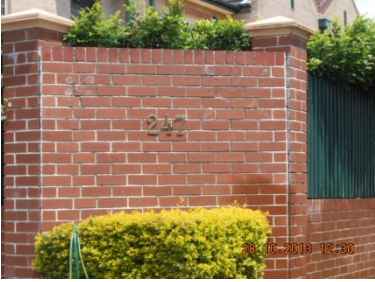
Item No.	Photo	Recommended Control Measure	Trade
RIGHT SIDE MAIN ENTRY BRICK WALL AT EASTERN DRIVEWAY			
16	Eastern brick wall driveway entry off Burwood Road

Please ensure an engineer monitors the movement and subsidence of the perimeter brick wall to ensure the safety and construction rigidity of the brick wall. Movement in the wall was evident at the time of the inspection. Recommendation to action: Quarter 1 – Action required within 3 months	Engineer / Bricklayer

8. Block F - All rendered and painted surfaces are to be attended to, and paint is needed to the external facade ceiling eaves lining.
9. Please ensure an engineer monitors the movement and subsidence of the perimeter brick wall to ensure the safety and construction rigidity of the brick wall. Movement in the wall was evident at the time of the inspection.
