# Tree Risk Assessment

Phillips Landing  
247 Burwood Road, Concord  
NSW, 2137  
DP 270051  
Job No: 26108  
10/08/2026

**Temporal Tree Management Pty Ltd.**

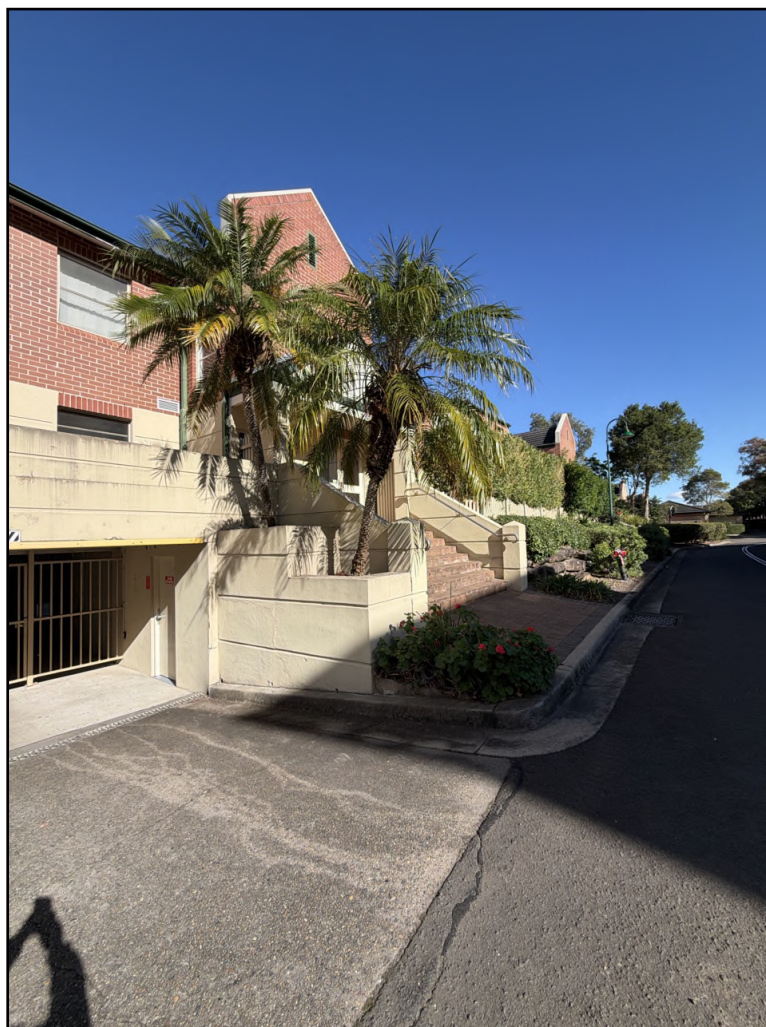
Tree No. : 90

Scientific Name : Phoenix roebelinii | pygmy date palm

Engage Structural Engineer to assess severity of damage to retaining walls adjacent to palm. If damage require remediation, palm may require removal.

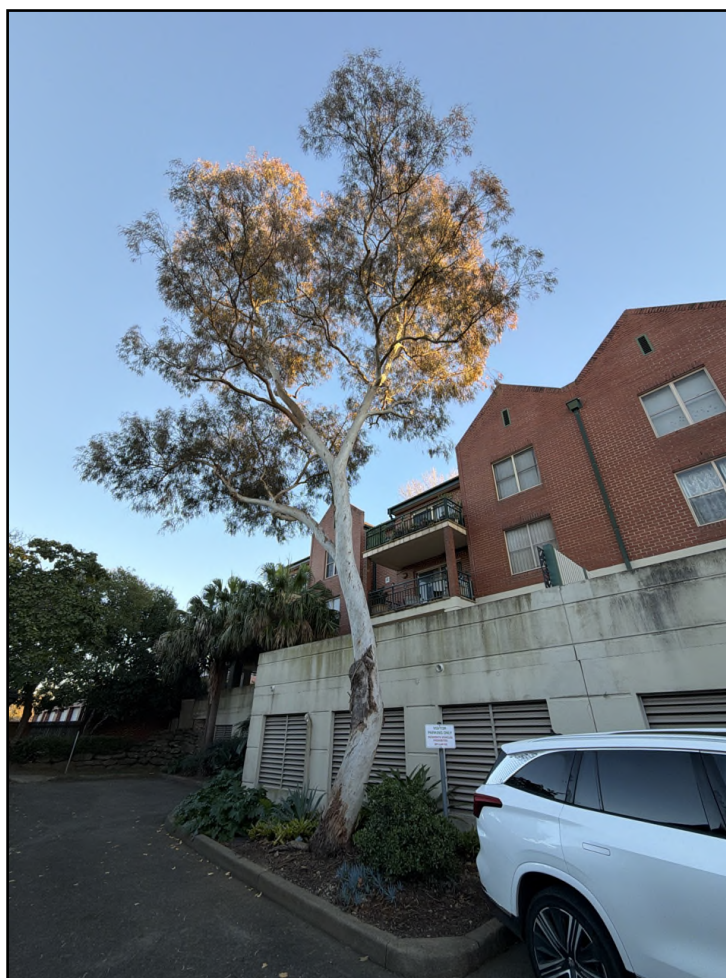
Tree No. : 30

Scientific Name : Eucalyptus robusta | Swamp Mahogany

Lightly reduce lateral branches in eastern, southern and western portions of canopy by up to 2 metres length back to secondary branch unions to improve overall canopy symmetry and reduce the likelihood of limb failure over pathway. Max cut diameter 80mm. Total live canopy reduction must not exceed 10%.

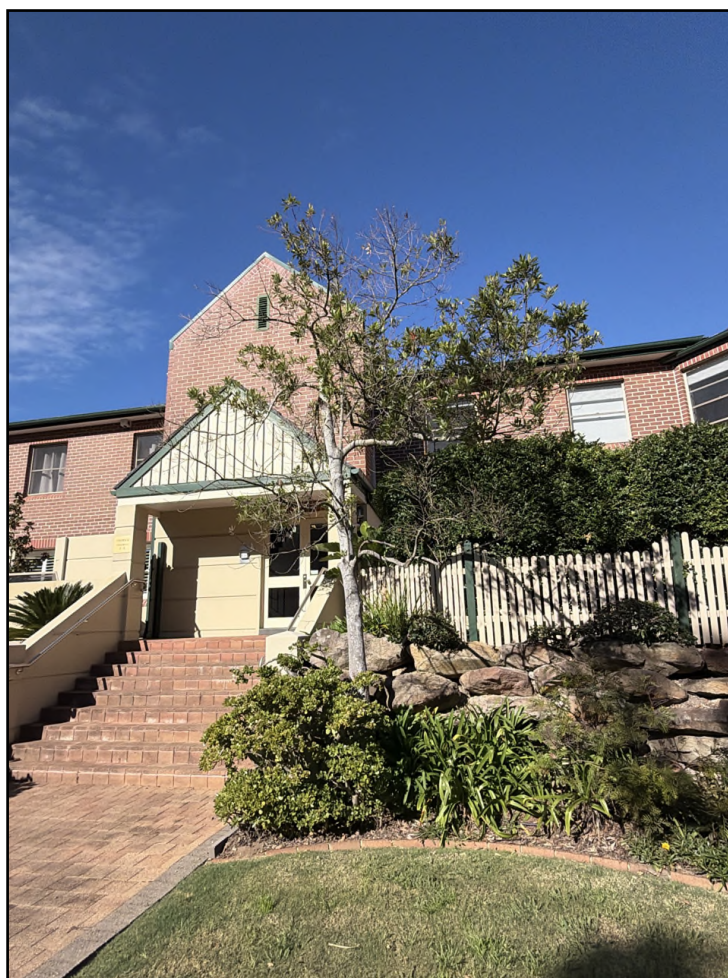
Tree No. : 79

Scientific Name : *Elaeocarpus reticulatus* | Blueberry Ash
